# Manhole Inspection Summary

Manhole # S47G2\_005MH

**Location** Address: **4210 Curtis Ave** Cross Street: **Olmstead-Locust**

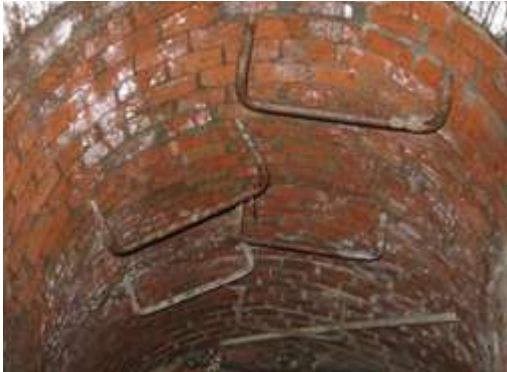
Steps

**Steps** Count: **5** Missing: **0** ☐ Corroded

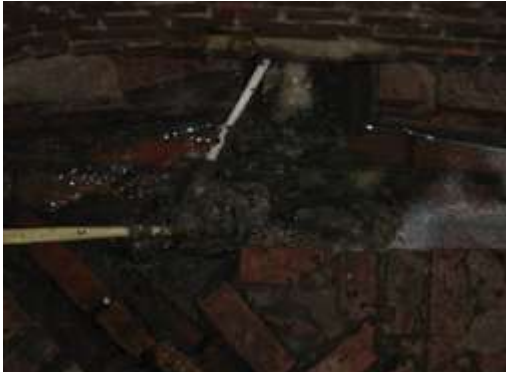
Defect 1

Channel

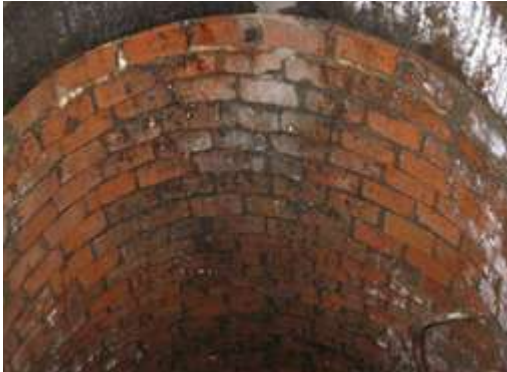
Defect 2

**Corbel** Material: **Brick** ☐ Parged Type: **Concentric/Eccentric**  
Condition: ☒ Sound ☐ Cracked ☐ Root Intrusion ☐ Loose Brick ☐ Deteriorated  
Infiltration: ☐ None ☐ Joint ☐ Cracks ☐ Mortar ☐ Roots ☒ Wall

wall

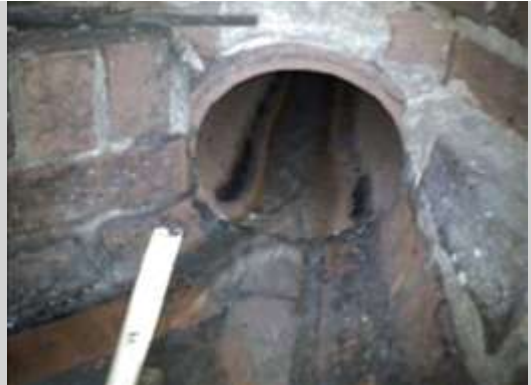
12 O'Clock Outflow

8 in. Circular Gravity Sewer  
Pipe Out @ 12 O'Clock

Pipe Height: **9.6** (in.) Rod and Bar (Angled)  
Pipe Material: **Clay** ☐ Pipe Lined  
Invert Depth: **9.34** (ft.) Flow Characteristics: **Fast**  
Deposits: ☒ None ☐ Mud ☐ Sludge ☐ Debris ☐ Grease  
Silt Depth: (in.) Deposits Extent:  
Infiltration: **None** Pipe Seal Cond: **Sound**

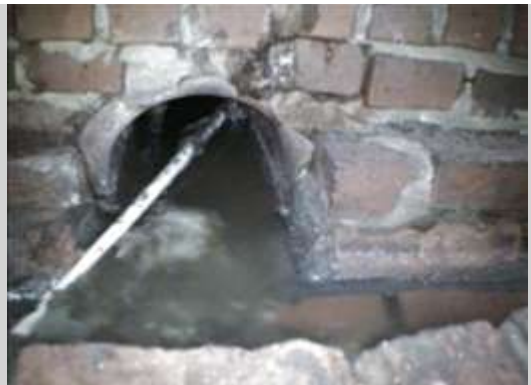
3 O'Clock Inflow

10 in. Circular Gravity Sewer  
Pipe In @ 3 O'Clock

Pipe Height: **9.6** (in.) Rod and Bar (Angled)  
Pipe Material: **Clay** ☐ Pipe Lined  
Invert Depth: **9.22** (ft.) Flow Characteristics: **Slow**  
Deposits: ☒ None ☐ Mud ☐ Sludge ☐ Debris ☐ Grease  
Silt Depth: (in.) Deposits Extent:  
Infiltration: **None** Pipe Seal Cond: **Sound**

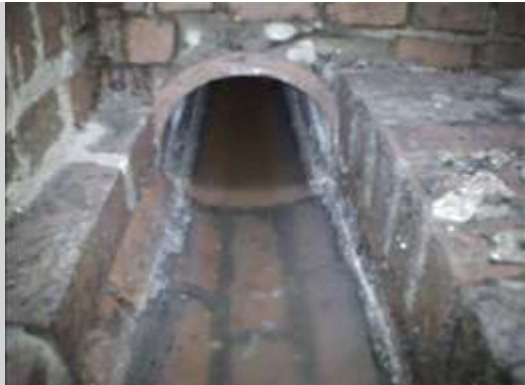
6 O'Clock Inflow

8 in. Circular Gravity Sewer

Pipe In @ 6 O'Clock

Pipe Height: **10.8** (in.) Rod and Bar (Angled)

Infiltration: **None** Pipe Seal Cond: **Sound**

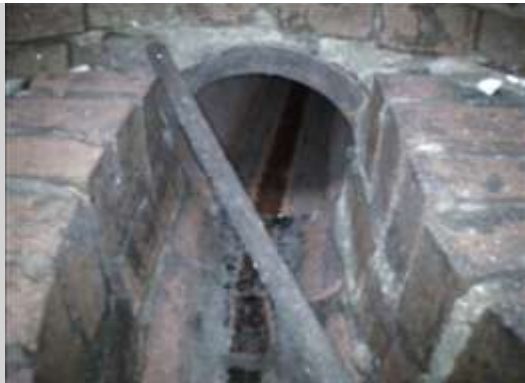
9 O'Clock Inflow

6 in. Circular Gravity Sewer

Pipe In @ 9 O'Clock

Pipe Height: **9.6** (in.) Rod and Bar (Angled)

Infiltration: **None** Pipe Seal Cond: **Sound**
